Reflective Cracking Testing Notes

Date: March 13, 2015

Project: Reflective Cracking Indoor Phase IV

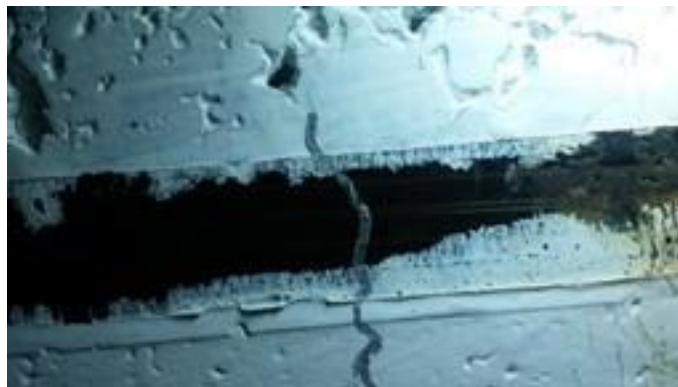
The 12 mil test cycle continued on the test item. On the South test section, both the inner and outer vertical edges show no change. On the North test section, the inner vertical edge shows no change. The North outer vertical edge crack has propagated 1/8 inch since yesterday (3/12/2015) to 3 1/8 inches total, as shown in Figure 1 below.

Figure 1. North Outer Vertical Edge - Crack.
